Advanced Turbine Technology

ATTAP

1990 Annual Report

DOE/NASA 0336-3
NASA CR-189142
EDR 15593

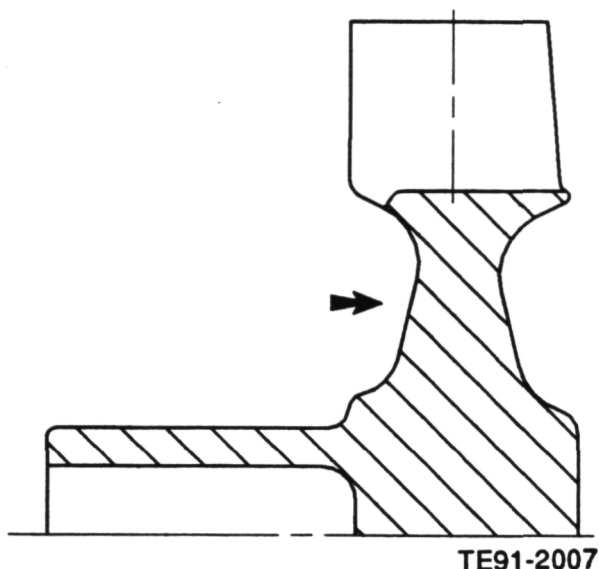
Figure 49. Failure site location of GTE rotor (S/N 656.)

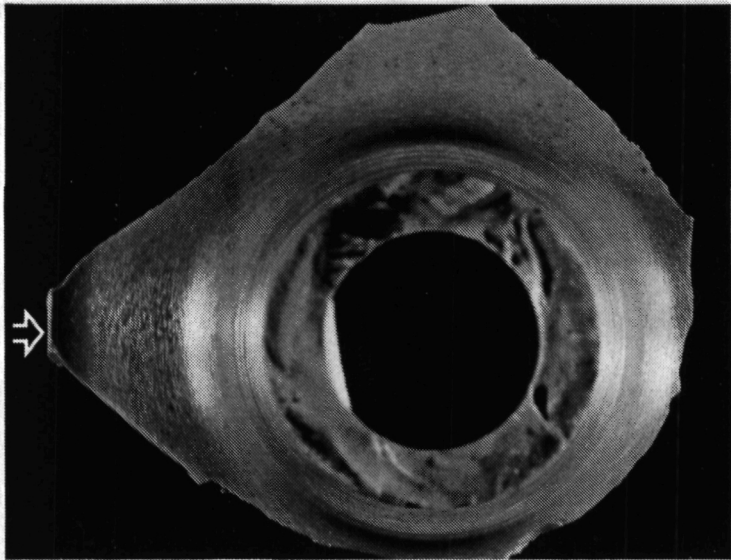
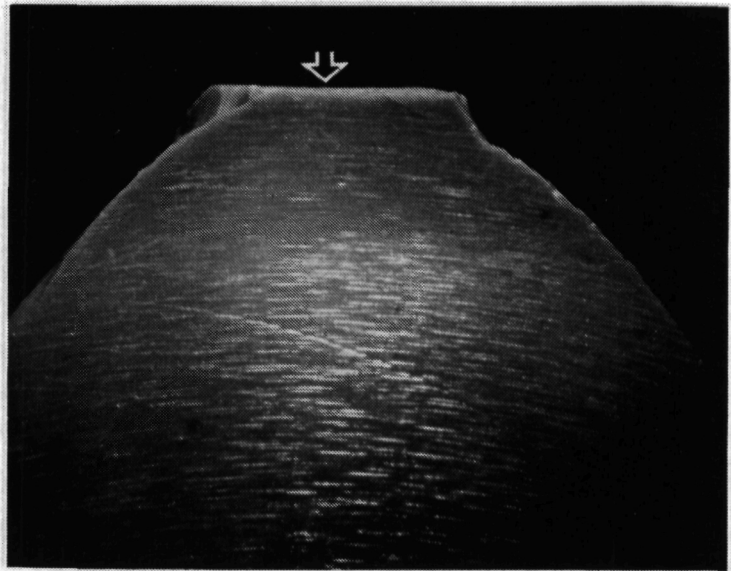
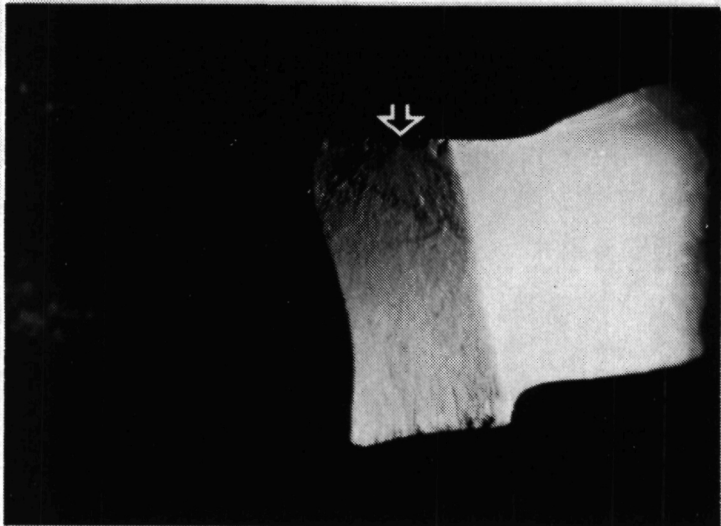
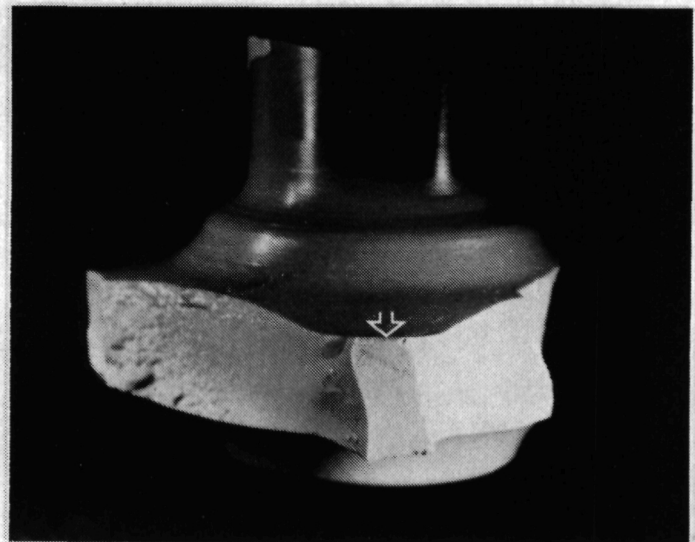
Figure 50. Failure origin of GTE rotor (S/N 639.)

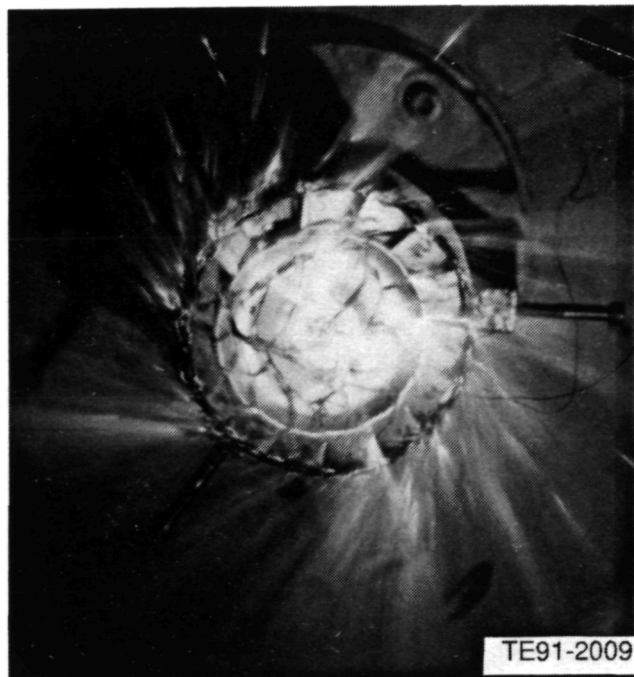
Figure 51. GTE rotor (S/N 647) at moment of burst, $N_1 = 75,500$.

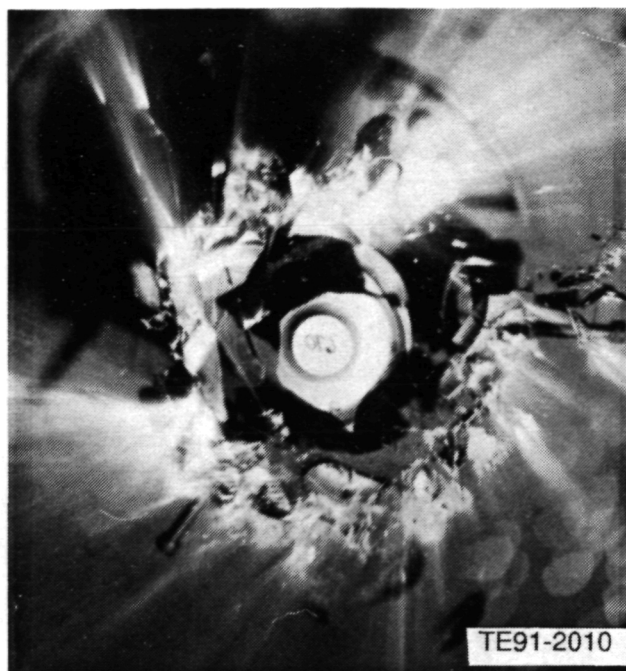
Figure 52. GTE rotor (S/N 670) just after failure, $N_1 = 56,900$.

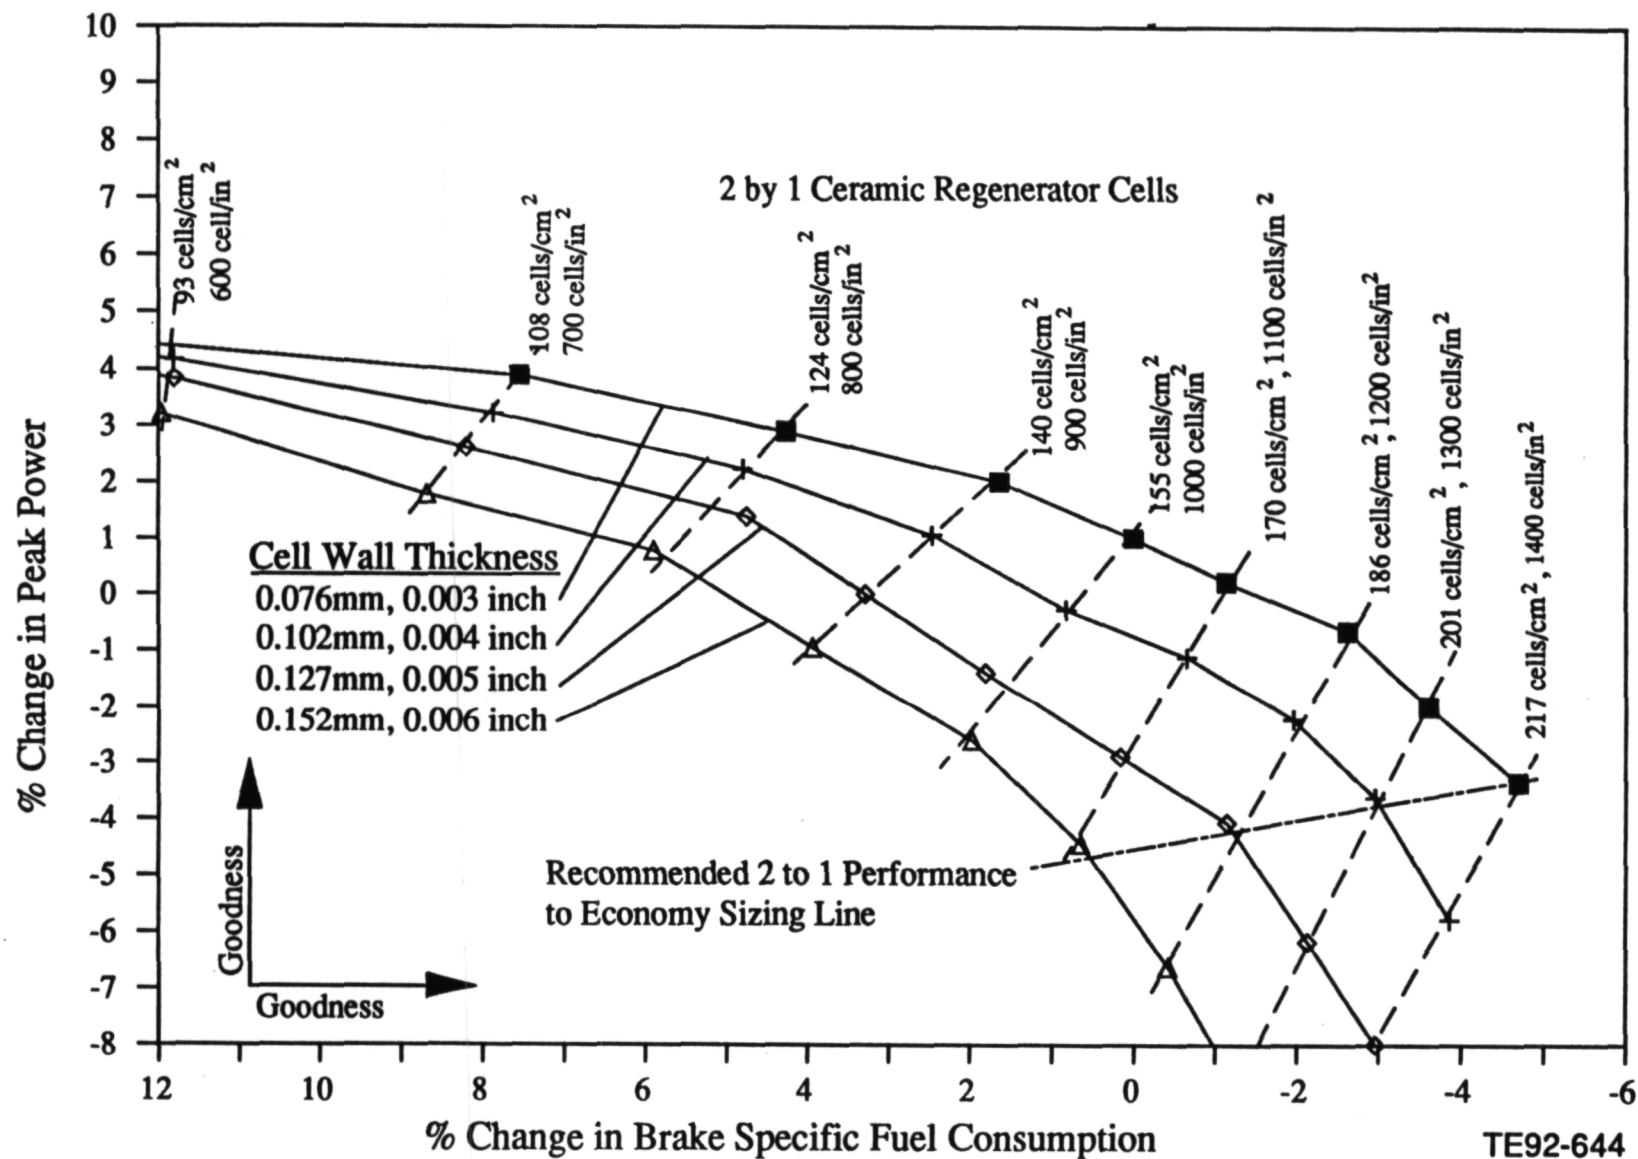
Figure 61. Ceramic regenerator matrix sizing study for recommended 2 to 1 performance to fuel economy trade-off ratio.

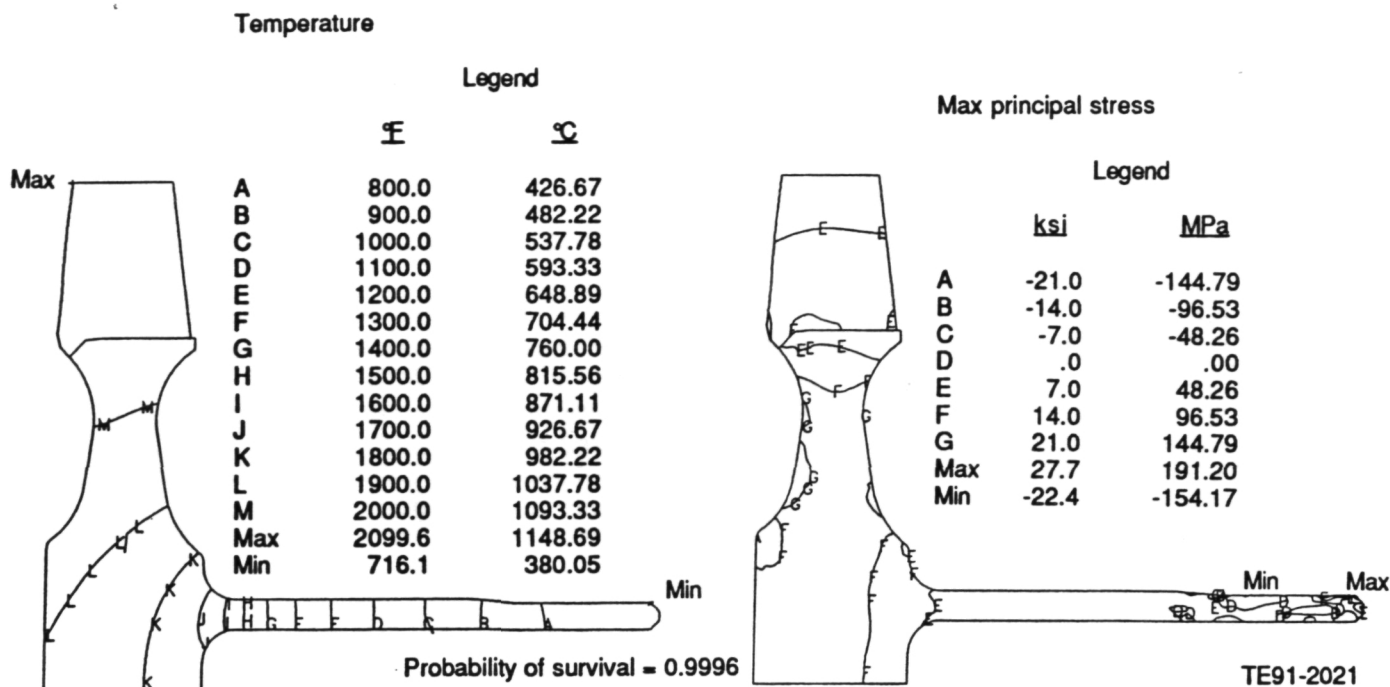
Figure 63. First-stage power turbine rotor temperature and stress distributions - SN252, steady-state.

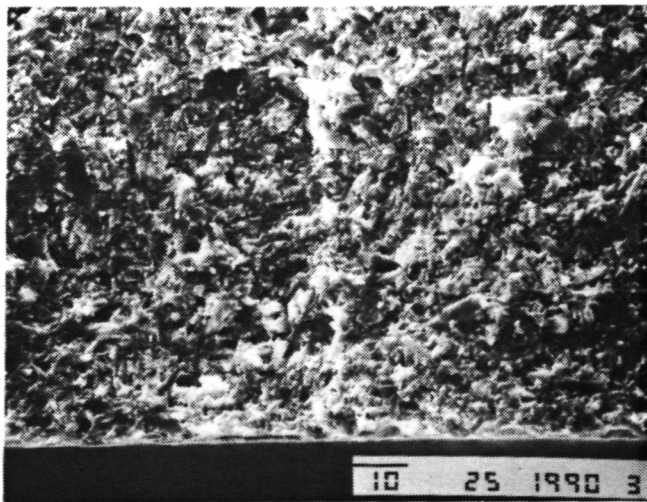
Figure 90. Typical fracture origin (surface flaw) observed in GCC GN-10 Si₃N₄ IEA test bars.

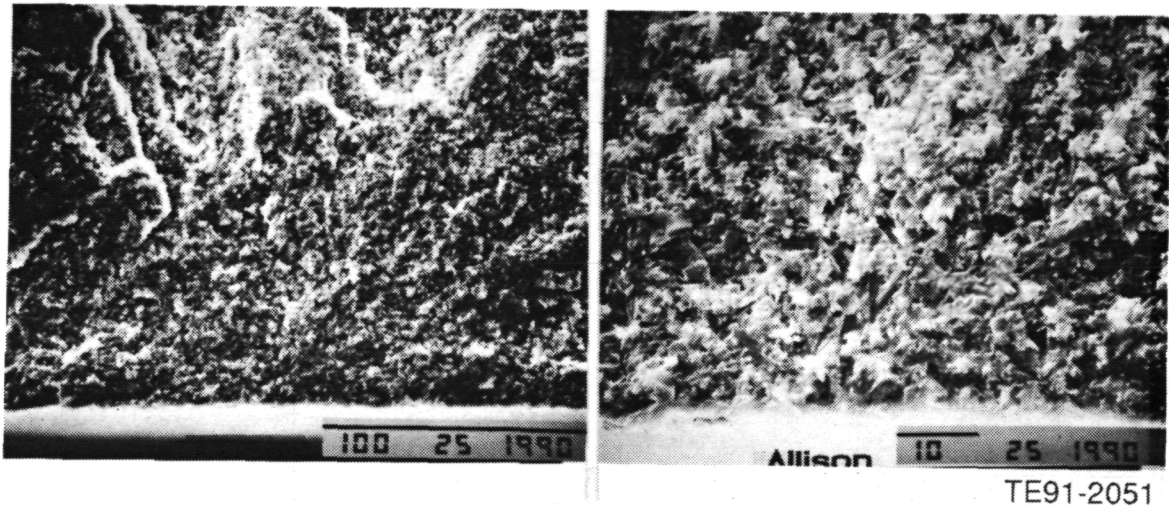
Figure 93. Typical fracture origin (surface flaw) observed in Norton/TRW NT154 Si_3N_4 machined bars tested at room temperature.

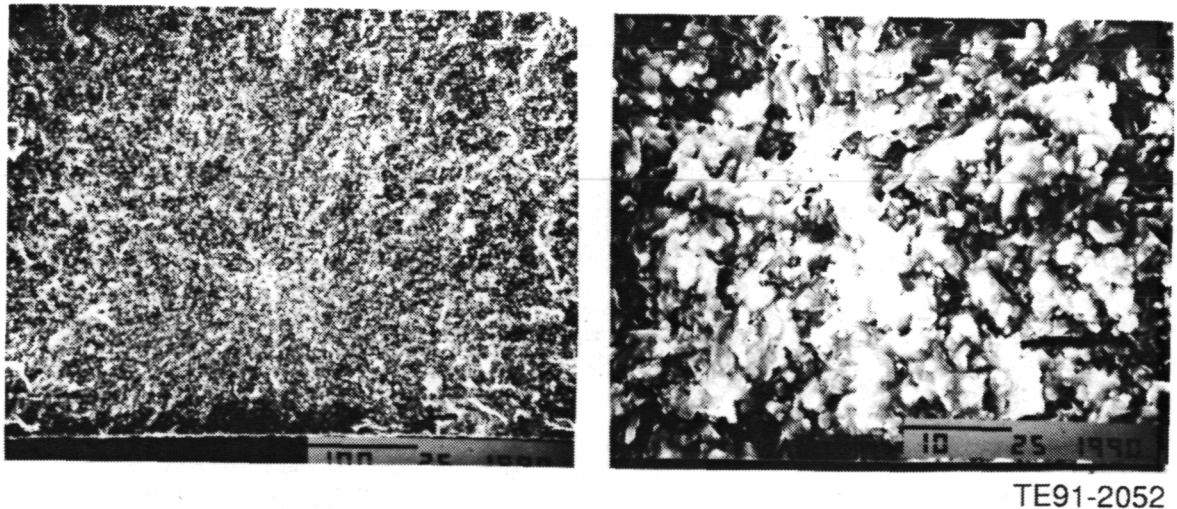
Figure 94. Typical fracture origin (internal pore) observed in Norton/TRW NT154 Si_3N_4 machined bars tested at 1370°C (2500°F).

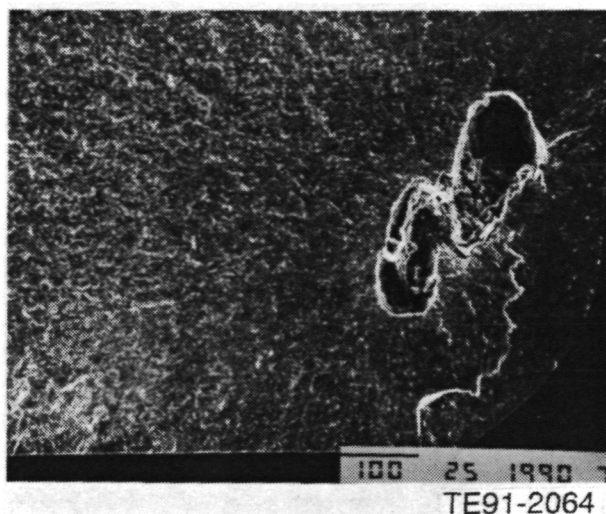
Figure 106. Fracture origin (internal pores) observed in Carborundum sintered SiC rotor S/N FX78523.

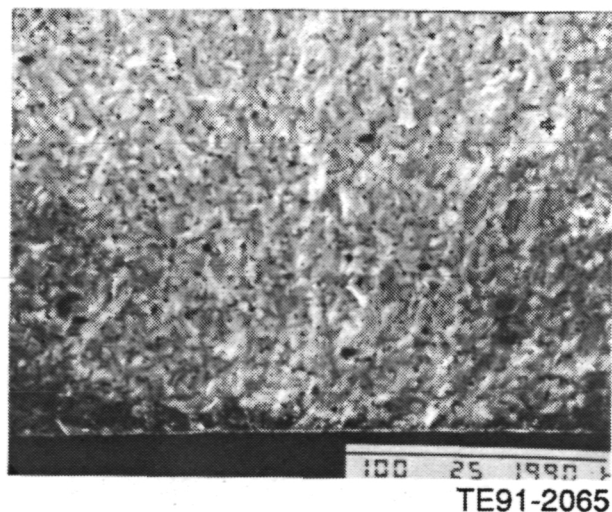
Figure 107. Typical fracture origin (surface flaw) observed in test bars cut from Carborundum sinter/HIPed SiC rotor S/N FX78520.

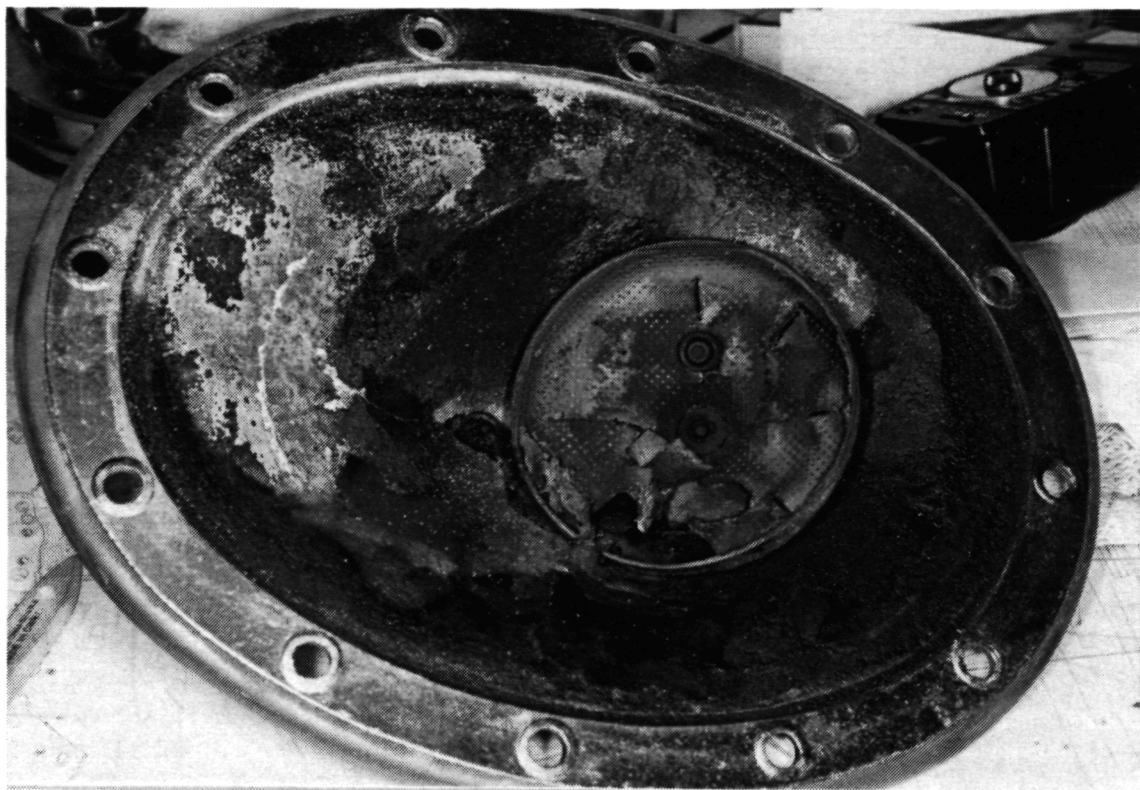
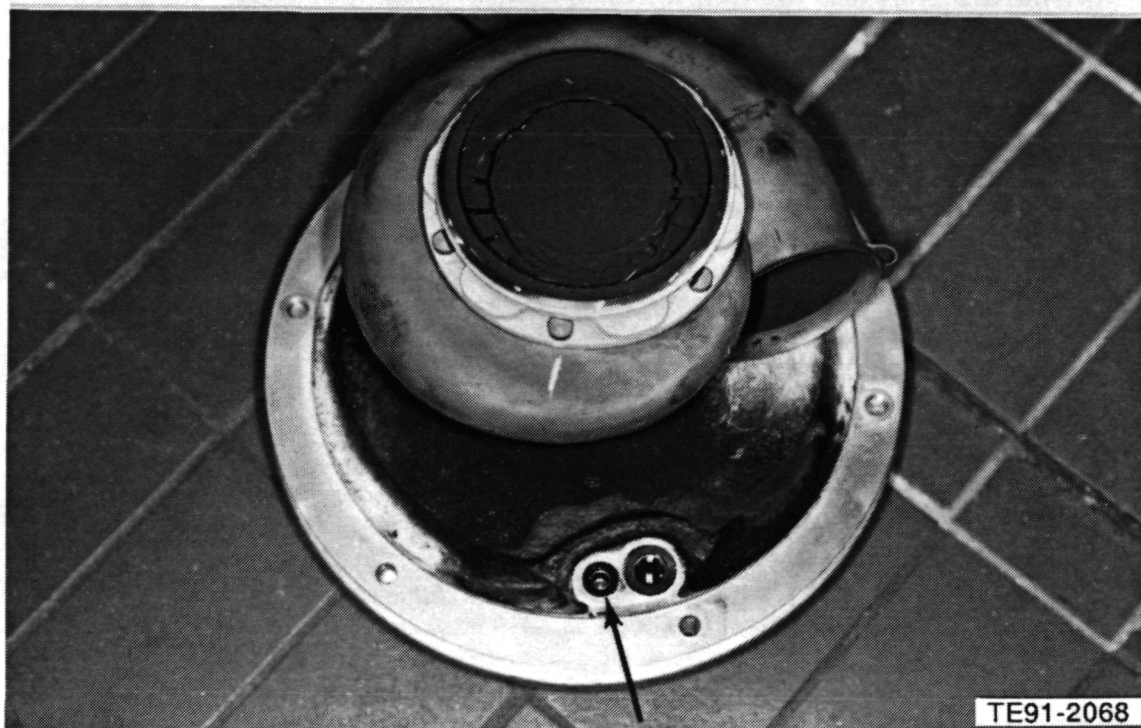
Figure 110. As-disassembled condition of combustor dome and burner cover insulation (top); black O-ring (pointed out by arrow in bottom photo).

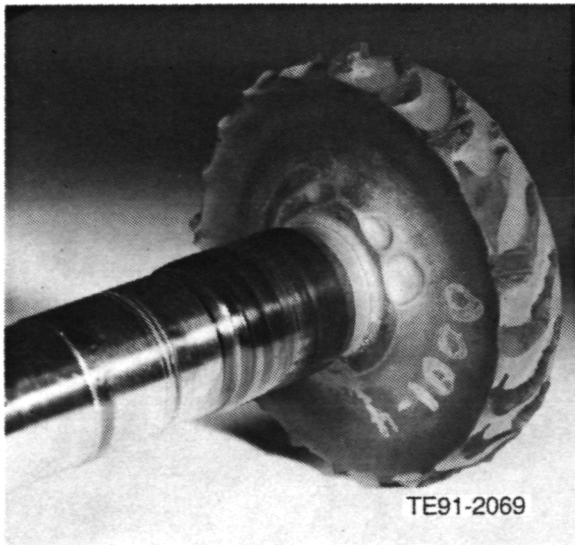
Figure 111. Gasifier turbine rotor (P/N 5-67200, S/N 0001-4) after laboratory cleaning.

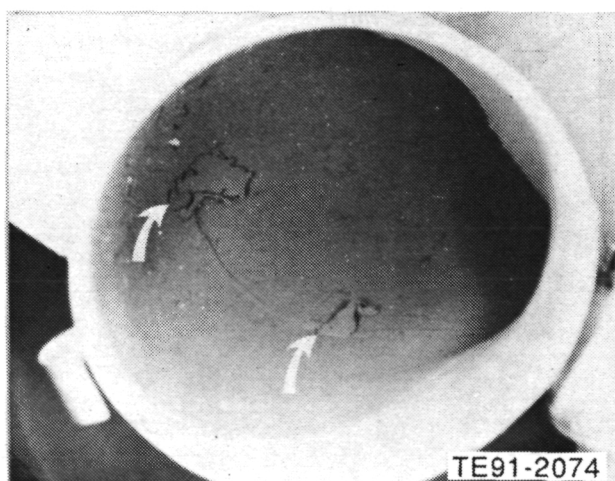
Figure 114. Two pieces of combustor dome welded to I.D. of scroll inlet.

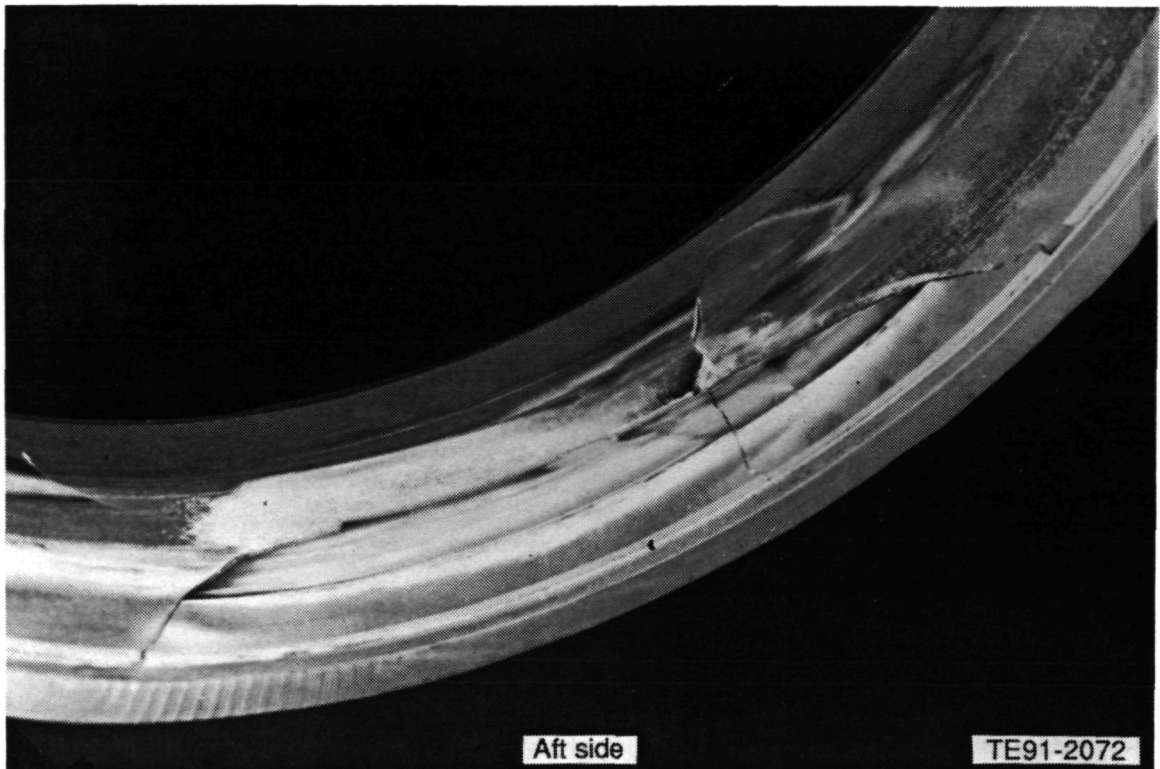
Figure 115. As-disassembled condition of the shroud.

The shroud, shown in Figure 115, fractured at the 10 o'clock position viewed from the aft side. The shroud was lightly rubbed all way around except for a region of heavy rub measuring 58.42 x 5.08 mm (2.3 x 0.2 in.) where the fracture occurred. The crack measured 78.7 mm (3.1 in.) in length. Figure 116 shows the reduced cross-section of the shroud at the region of heavy rub.

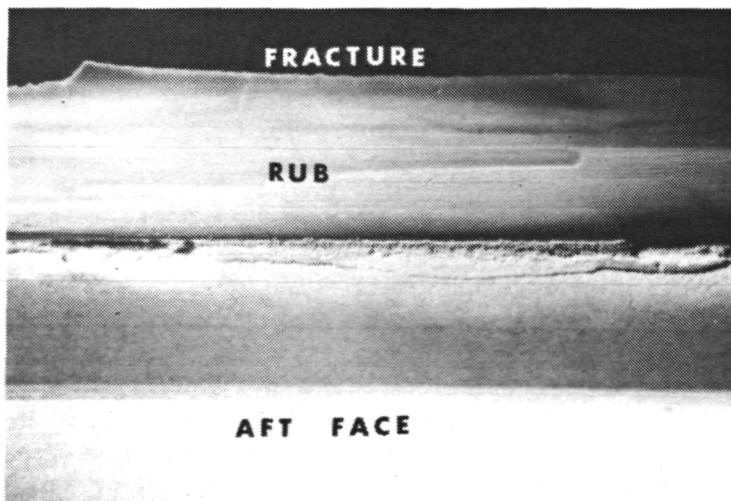
Figure 116. Rubbed I.D. surface on the aft side (left) and the cross-section of the piece (right).

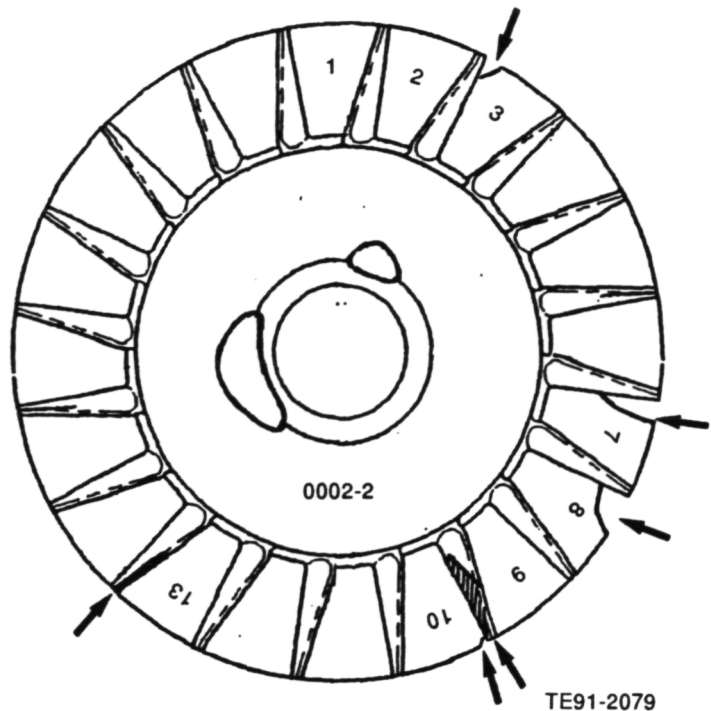
- 3: Small chip at trailing edge (TE) tip
- 7: Large chip at TE tip
- 8: Large chip at TE tip
- 9: Large chip at leading edge (LE)
- 10: Small chip at TE tip
- 13: Small chip at LE
- 11 - 20: Rub marks on middle and TE tips

Figure 121. Schematic of damage to Kyocera gasifier rotor S/N 5K25.

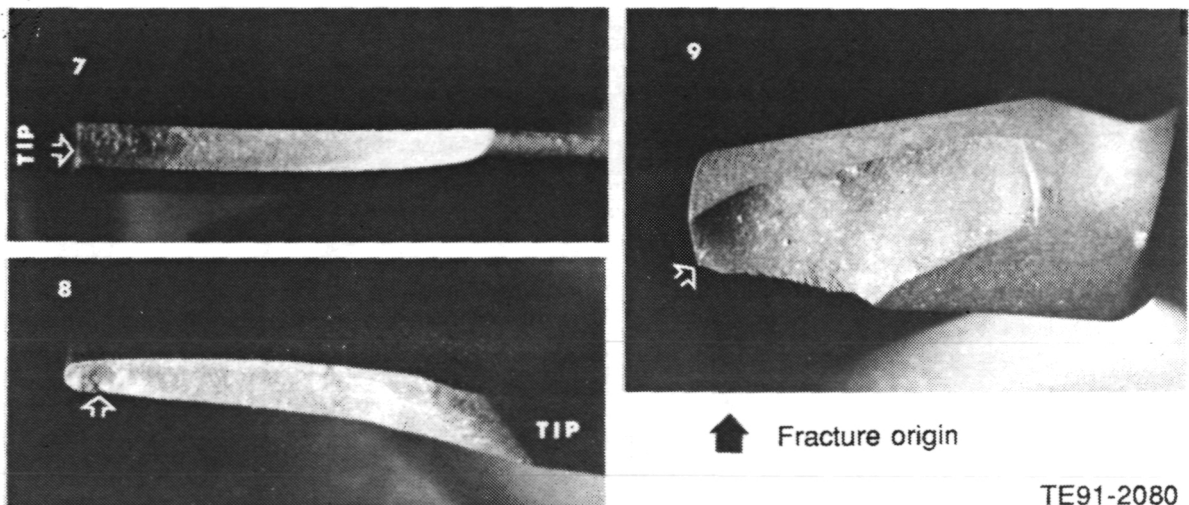
Figure 122. Fracture origins in Kyocera rotor S/N 5K25 airfoils.

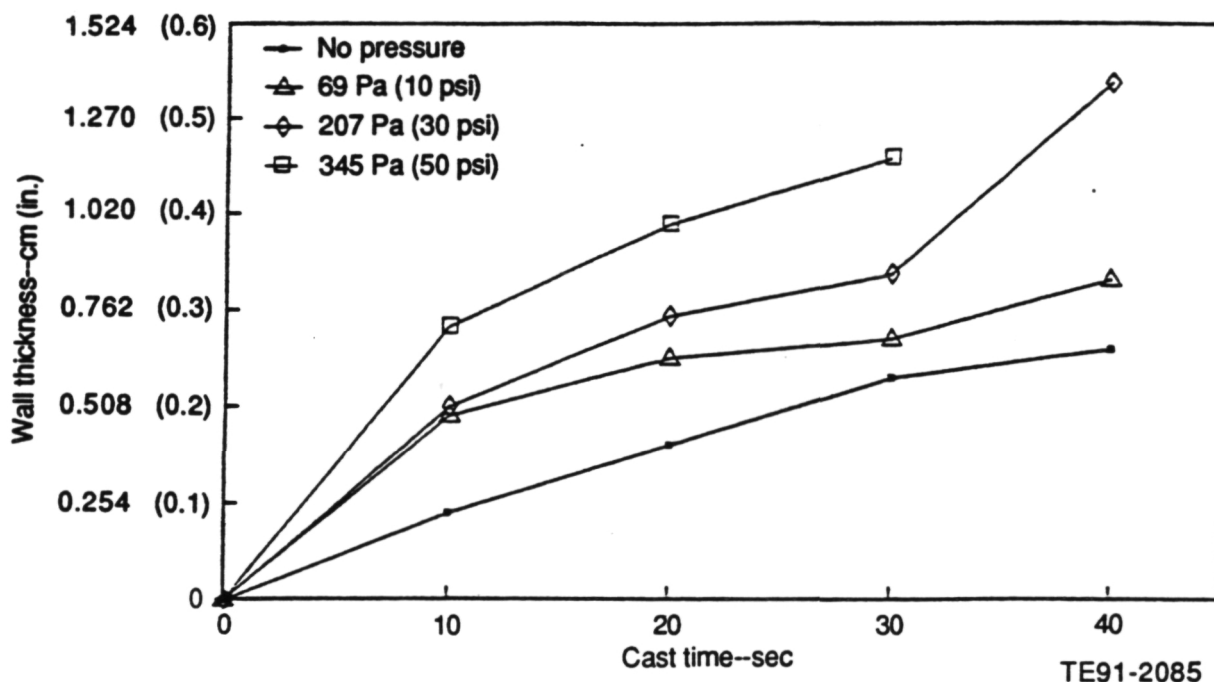
Figure 127. Effect of casting time and pressure on wall thickness; CBO low pressure slip casting.

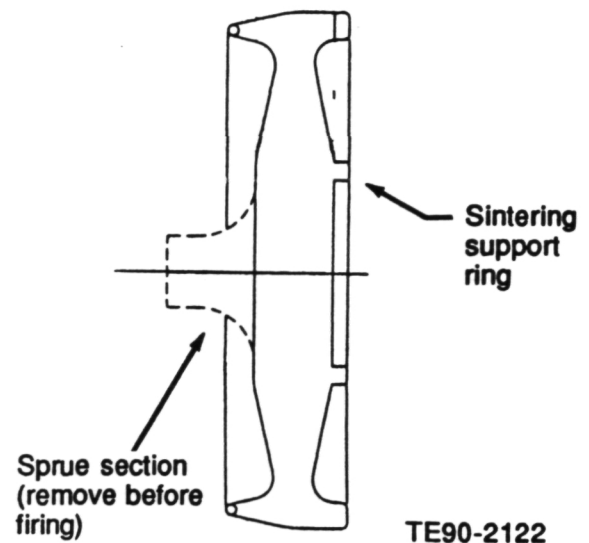
Figure 139. CPS vane platform configuration.

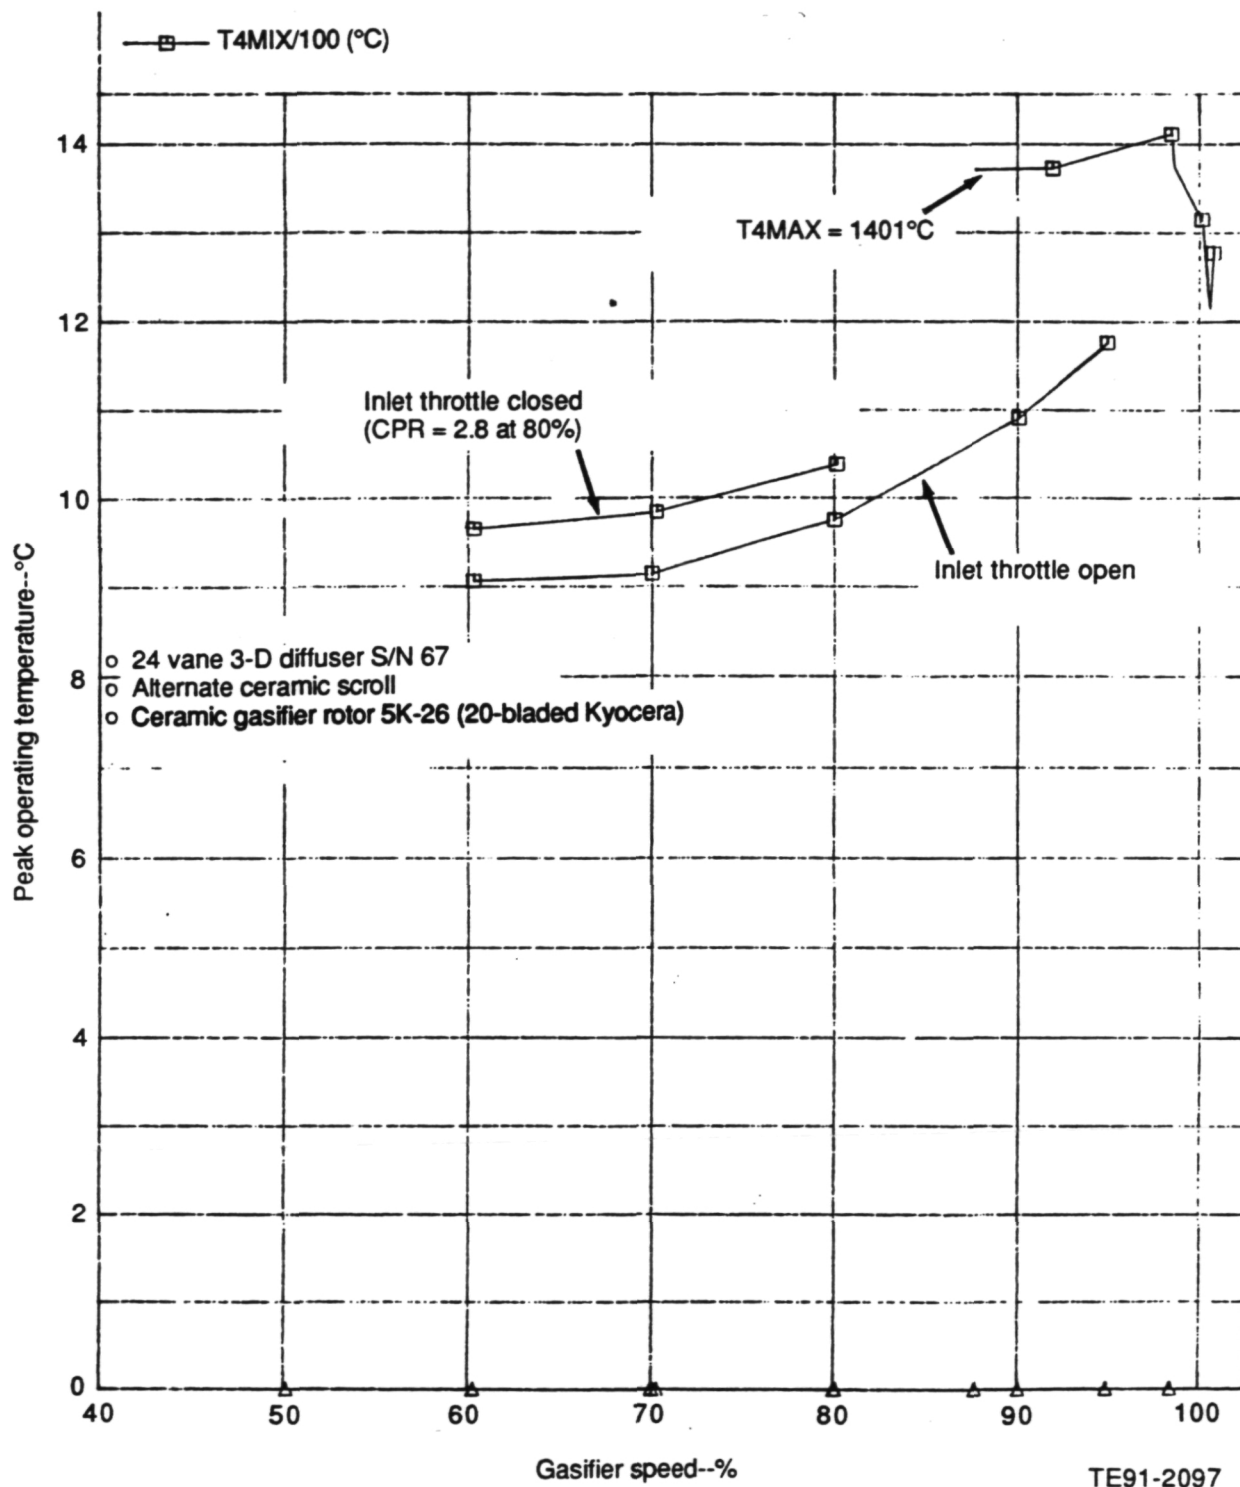
Figure 141. Peak operating temperature versus speed: advanced concept ceramic scroll test.
